Prepared for:

GuideOne Insurance - Commercial Lines

Betterview Ref ID:

8094730

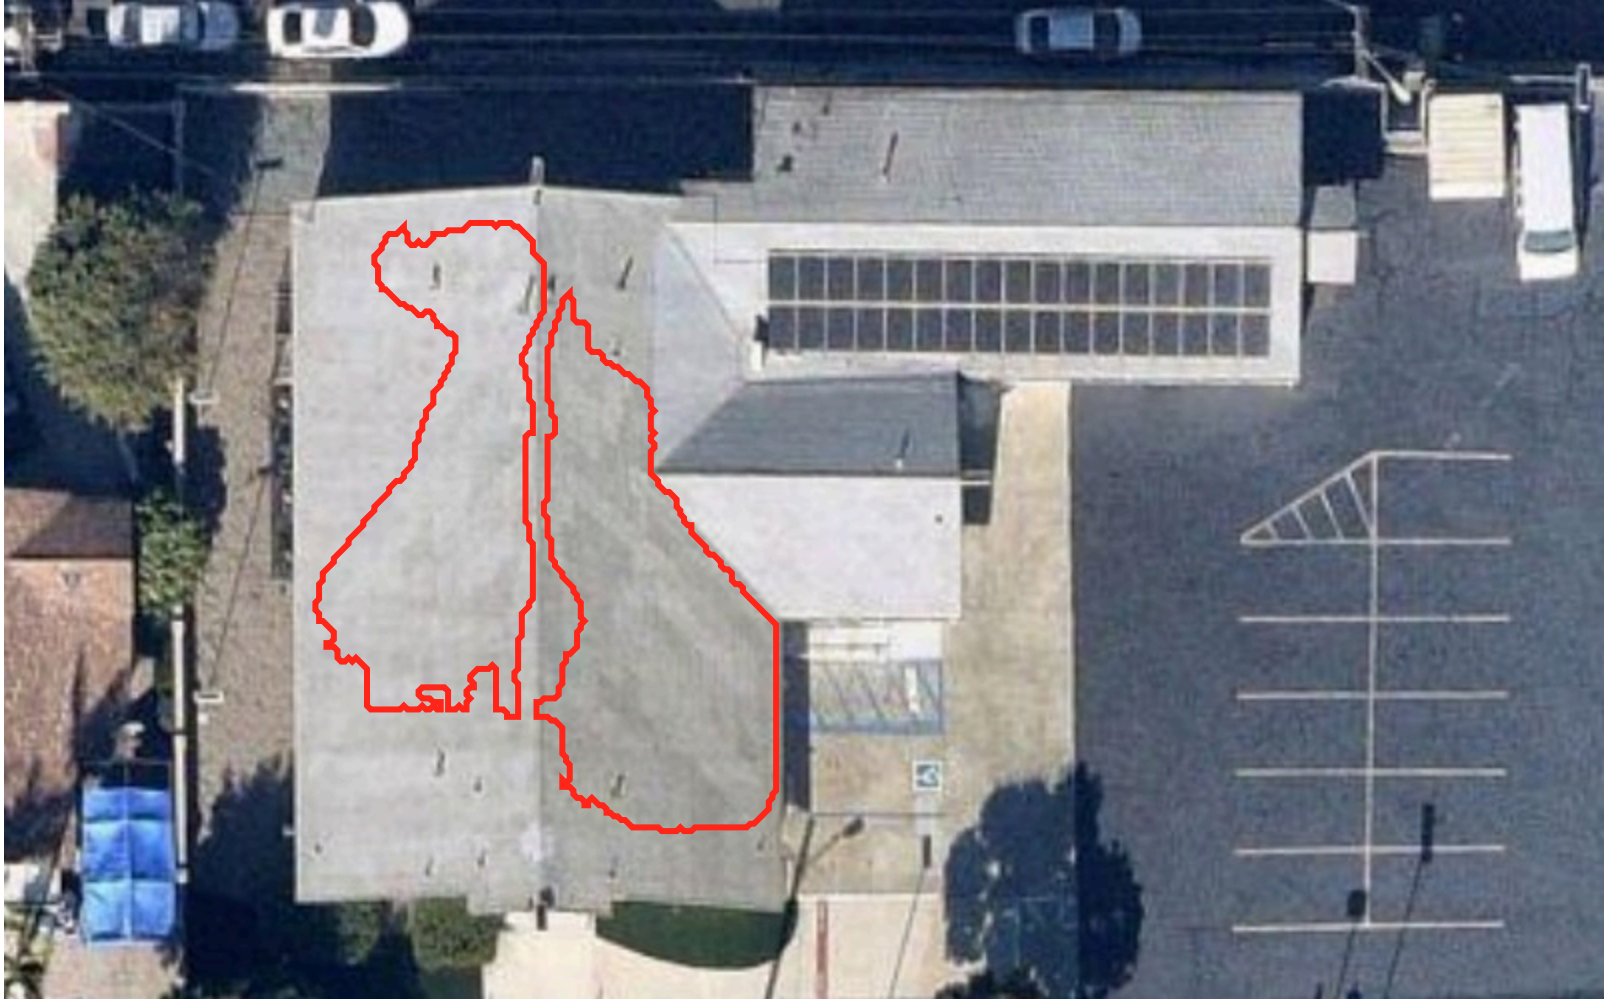
Roof Spotlight Index

24 out of 100

Building: 1
Roof Footprint: 6,794 ft²
Shape: Gable (99% Confidence)
Material: Asphalt Shingle (81% Confidence)

Structural Damage	None
	Missing Shingles	None
	Worn Shingles	Prevalent (27%, 1,813 ft ²)
	Tarp	None
	Rust	None
	Patching	None
	Ponding	None
	Staining	None
	Debris	None
	Overhang	None
