Prepared for:

GuideOne Insurance - Commercial Lines

Betterview Ref ID:

8094730

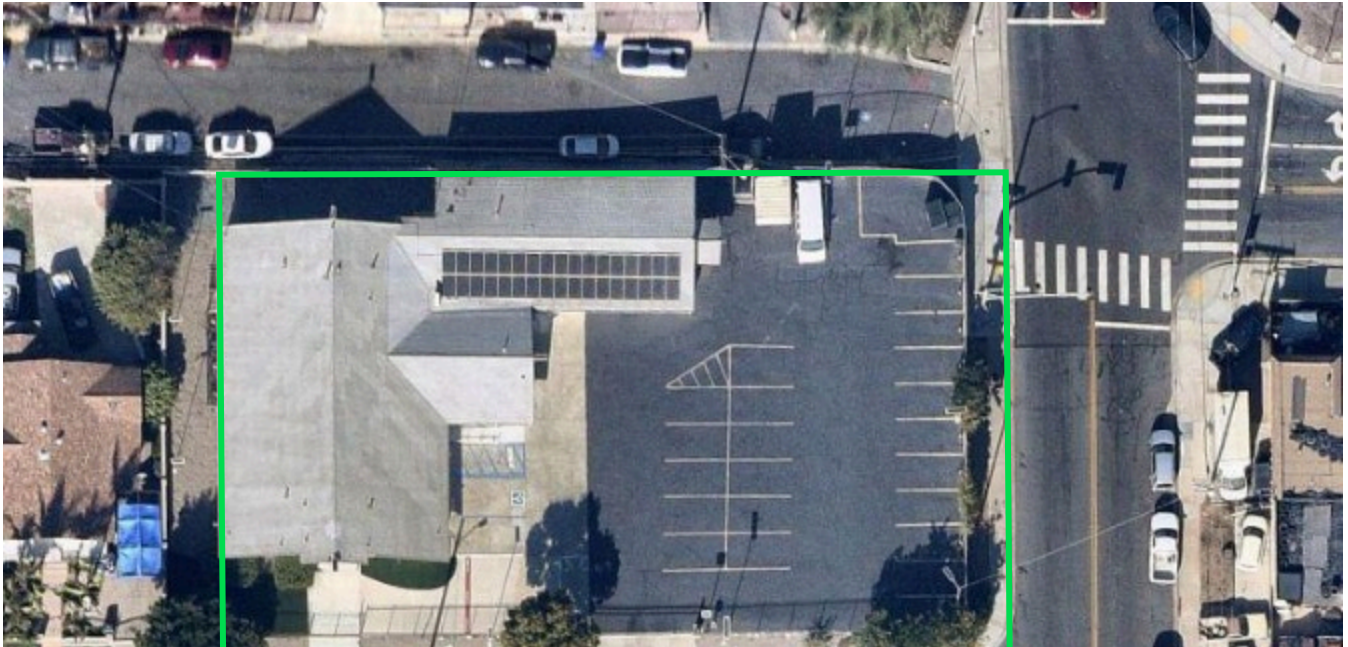
Building: 1
Roof Footprint: 6,794 ft²
Shape: Gable (99% Confidence)
Material: Asphalt Shingle (81% Confidence)

Structural Damage	None
	Missing Shingles	None
	Worn Shingles	Prevalent (27%, 1,813 ft ²)
	Tarp	None
	Rust	None
	Patching	None
	Ponding	None
	Staining	None
	Debris	None
	Overhang	None
